DEPARTMENT OF TRANSPORTATION**DIVISION OF ENGINEERING SERVICES**

Quality Assurance and Source Inspection

Contract #: 04-0120F4Cty: SF/ALA Rte: 80 PM: 13.2/13.9File #: 1.28**WELDING INSPECTION REPORT****Resident Engineer:**Siegenthaler, Peter**Address:** 333 Burma Road**City:** Oakland, CA 94607**Report No:** WIR-021610**Date Inspected:** 07-Mar-2011**Project Name:** SAS Superstructure**OSM Arrival Time:** 700**Prime Contractor:** American Bridge/Fluor Enterprises, a JV**OSM Departure Time:** 1730**Contractor:** American Bridge/Fluor Enterprises, a JV**Location:** Job Site

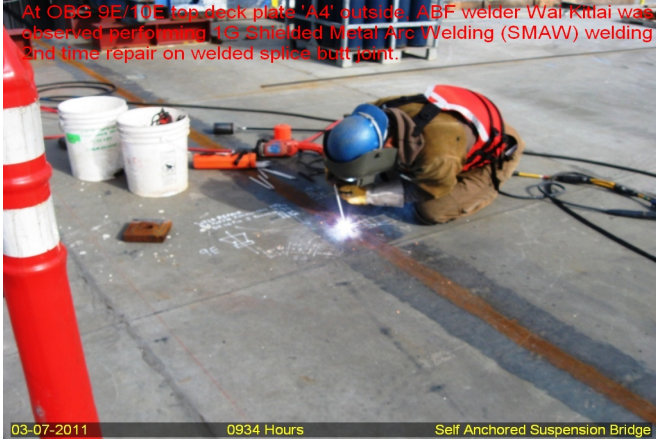
At OBG 9E/10E top deck plate 'A4' & 'A5' outside, QA randomly observed ABF/JV qualified welder Wai Kitlai continuing to perform CJP repair welding. The welder was noted welding in 1G (flat) position utilizing SMAW with 5/32" diameter E7018H4R electrode implementing new Caltrans approved Welding Procedure Specification (WPS) ABF-WPS-D15-1003 Repair. The new repair procedure includes putting in place a copper backing alongside the typical steel backing bar when the repair excavation is expected to occur at the edge of the steel backing. The first, second and third time welding repairs were excavated to a boat shape profile and were tested

with Magnetic Particle Testing (MT) prior welding. The third time welding repair located at A4 Y=4820 has Repair Welding Request (RWR) number of 2011-02-004. During welding, ABF QC John Pagliero was noted monitoring the welder and his welding parameters. QA noted parameter during welding was 165 amperes which appears in compliance to the WPS. The locations of the repairs were noted below;

Location	Y-dimension	Length	Width	Depth	Remarks
1. A4	2000mm	90mm	15mm	12mm	Completed (R2)
2. A4	4820mm	100mm	15mm	13mm	Completed (R3)
3. A5	5180mm	100mm	20mm	22mm	Completed (R1)

At OBG 9E/10E top deck plate 'A4' outside, ABF welder Wai Kitai was observed performing 1G Shielded Metal Arc Welding (SMAW) welding and time repair on welded splice butt joint.

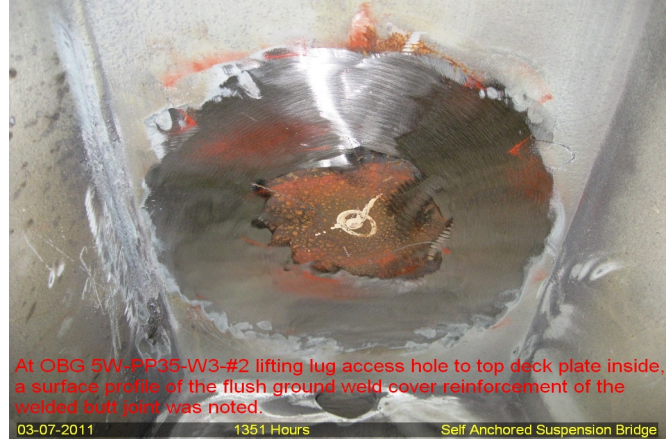
At OBG 5W-PP35-W3-#2 lifting lug access hole to top deck plate inside, a surface profile of the flush ground weld cover reinforcement of the welded butt joint was noted.

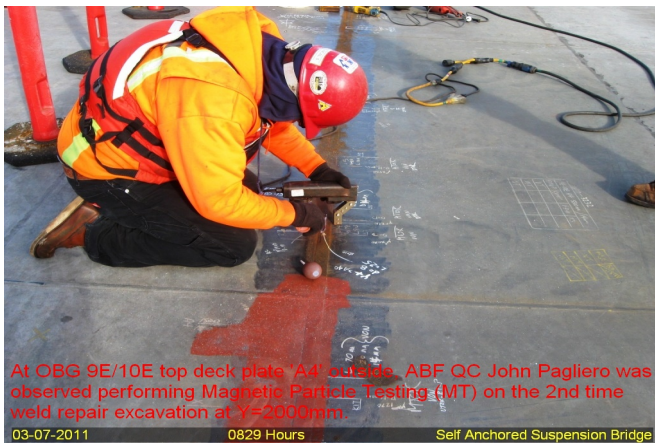
At OBG 9E/10E top deck plate 'A4' outside, ABF QC John Pagliero was observed performing Magnetic Particle Testing (MT) on the 2nd time weld repair excavation at Y=2000mm.

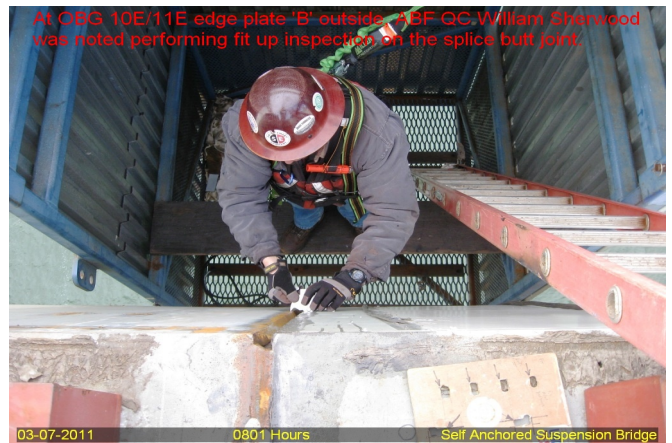
At OBG 10E/11E edge plate 'B' outside, QA randomly observed ABF/JV qualified welder Fred Kaddu perform root pass welding on the Complete Joint Penetration (CJP) splice butt joint. The welder was observed manually welding in the 3G (vertical) position utilizing a Shielded Metal Arc Welding (SMAW) with 1/8" diameter E7018H4R electrode and implementing Caltrans approved Welding Procedure Specification (WPS) ABF-WPS-D15-1040B. The joint being welded has a single V-groove butt joint with steel backing bar. ABF Quality Control (QC) William Sherwood was noted monitoring the welding parameters of the welder. QA randomly monitored the welding parameter with reading of 135 amperes which appears in conformance to the contract requirements. Prior welding, QA and ABF QC performed a joint fit up inspection/verification and measured an offset of 1.5mm and a root gap of 9.0mm which also appear in compliance to the contract requirements. At the end of the shift, SMAW root pass welding was still continuing and should remain tomorrow.

At OBG 10E/11E edge plate 'B' outside, ABF QC William Sharwood was noted performing fit up inspection on the splice butt joint.
